# Tank fire caused by cutting torch

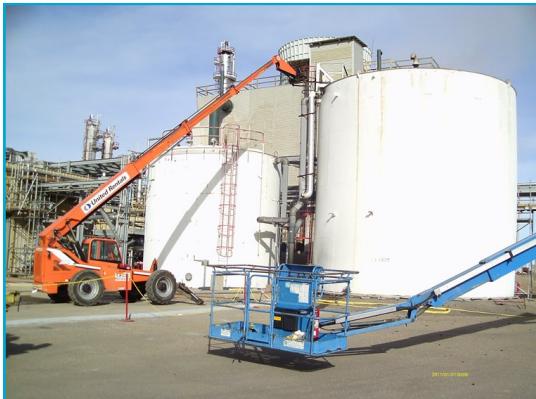
*Photo left:* East neutralization tank

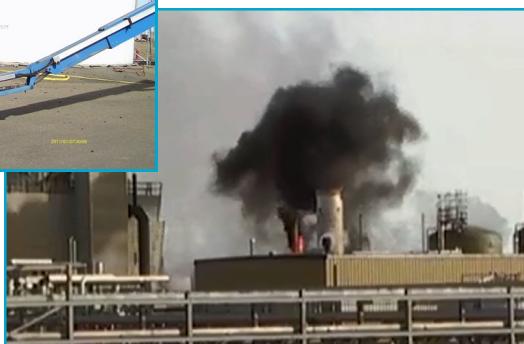
*Photo below:* Smoke and flames during the fire

When the pipe cut was approximately three-quarters complete using the oxy-acetylene torch, the workers noticed black smoke (presumably from the internal PVC tank liner) issuing out of a tank vent atop the tank and from the lower end of the piping being cut. The worker in the basket discontinued cutting and the worker on the ground went to get a water hose to douse the source of the black smoke. Before the ground worker returned with the hose, the black smoke issuing from the tank increased dramatically. Pressure building up in the tank blew out of the top vent and opened a safety relief or "thief" hatch. Moments later, associated PVC piping on the outside of the tank ruptured at the elbow and blew apart. Flames and black smoke could be seen coming from the top of the tank. Smoke from other openings in the tank engulfed the worker in the basket, so he enabled the "drive" and "down" controls on the aerial work platform to move away from the tank and get to the ground as quick as possible. Workers evacuated safely from the tank vicinity, with no injuries. The fire was largely self-extinguished within the first minute, due to lack of fuel and oxygen at the source, inside the tank. Methanex fire responders completely extinguished the remaining embers by purging the tank with steam.

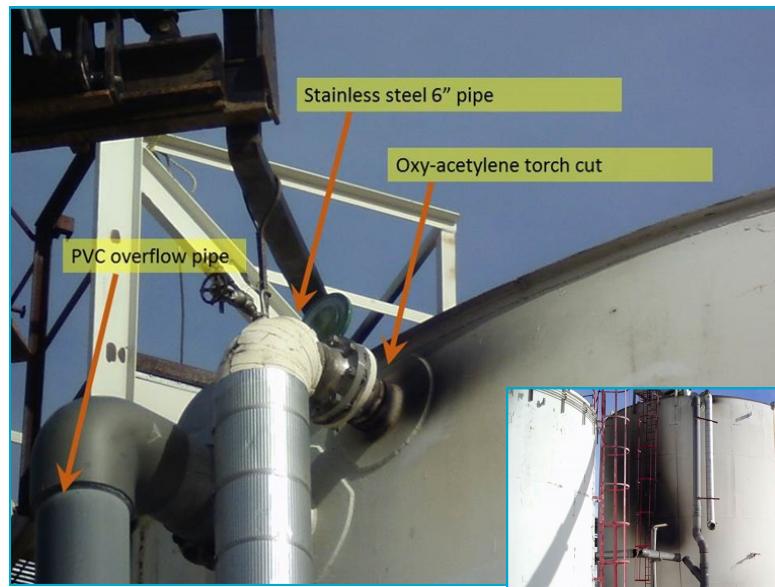
Photo below: Close-up of the tank nozzle

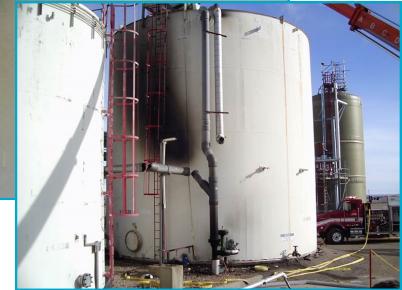
*In an enclosed space, exposed to continuous high heat and flames, these by-products may have built up and ignited, and caused a pressure increase that subsequently lifted the thief hatch and ruptured piping.*

Photo below right: Smoke stain from ruptured PVC pipe opening
